Full-Scale Testing of SC Series

Bahram M. Shahrooz, PE, FACI, FASCE, FSEI
Director of University of Cincinnati Large Scale Test Facility

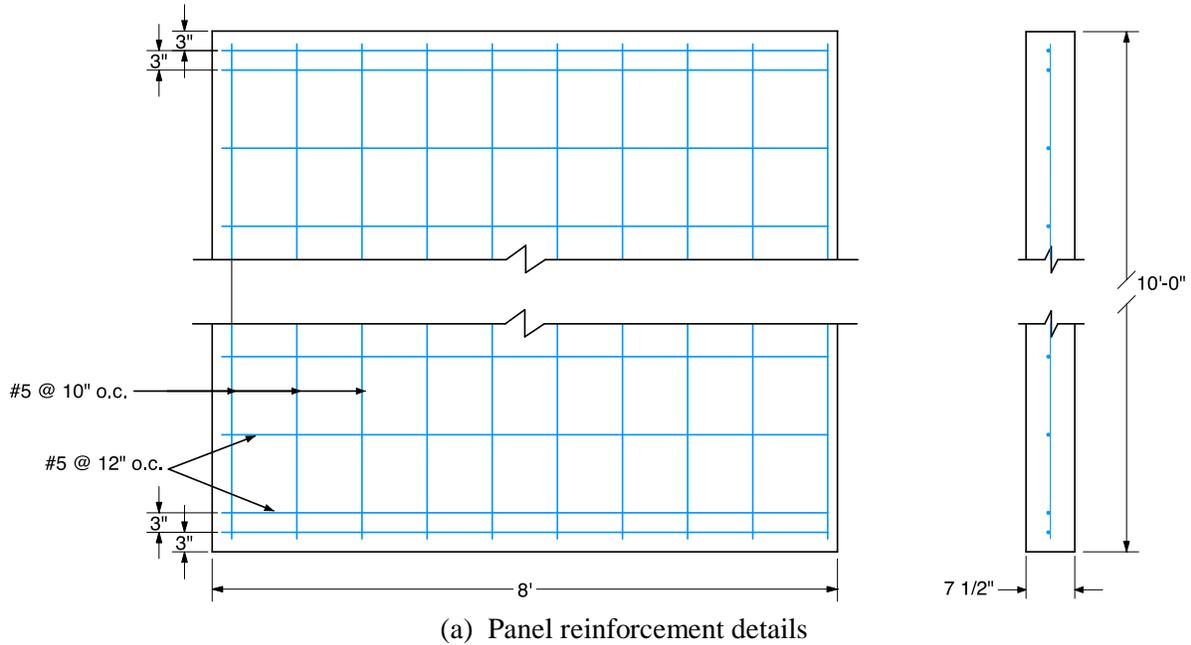
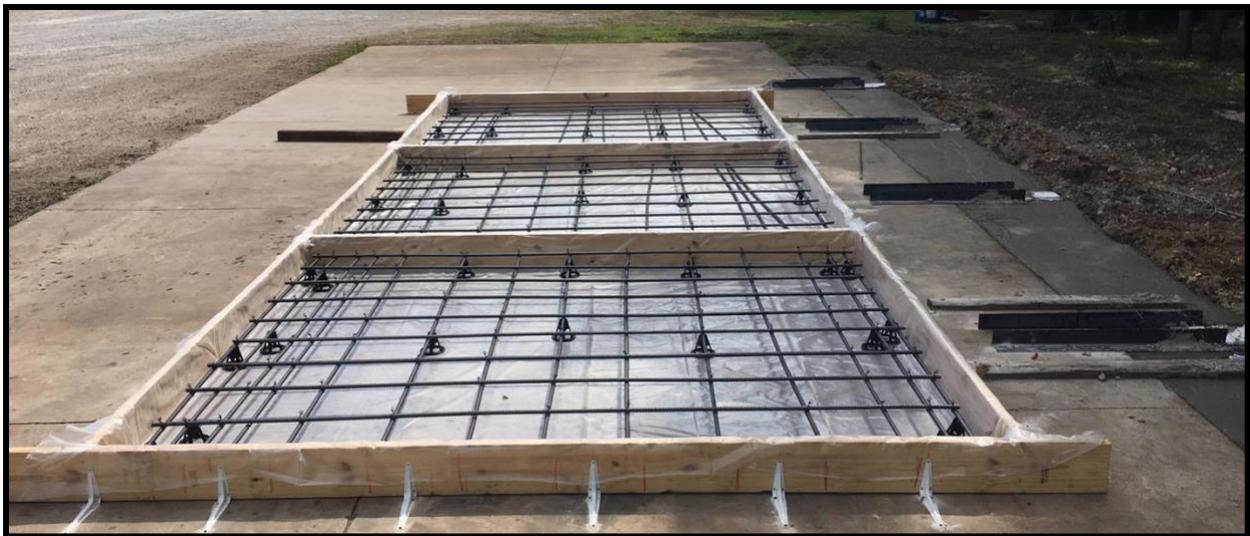
Figure 1. Panel details

Three 7.5" thick x 8'-0" wide x 10'-0" tall reinforced concrete panels were cast in order to test a number of AdvanConn devices under various loading configurations. The panels were reinforced with one curtain of No. 5 Gr. 60 reinforcing bars spaced vertically at 10" o.c. and at 12" o.c. horizontally. The reinforcement was placed at mid-thickness. The average 28-day concrete strength was 4,610 psi. Near the ends, where the devices were to be installed, the spacing between the horizontal bars was reduced to 3" based on common practice. The reinforcement layout is illustrated in Figure 1a. The photograph in Figure 1b shows the panel reinforcement and formwork. The panels were designed to allow multiple tests on each panel or three interconnected panels.

(b) Panels before concrete placement

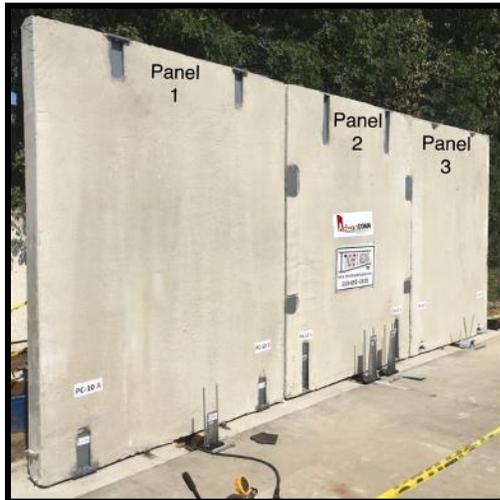
(a) Panels before bracing

After adequate curing, each panel was tilted upright (Figure 2a) and connected to a 24" wide by 30" deep foundation reinforced with No. 5 Gr. 60 reinforcing bars, and braced as shown in Figure 2b. Approximately 1/8" gap was kept between the panel and lateral braces. The panel at the contact point to the brace was ground and greased (Figure 2c). The combination of having a gap and the greased surfaces eliminated any potential influence of friction between the panel and lateral bracing system on the test results. It should be noted that the tests were conducted without any grout between the panel and foundation.

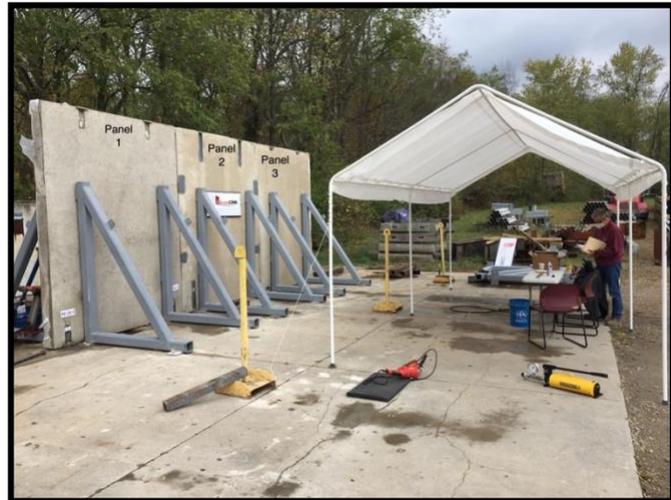
(b) Panels after installation of lateral braces

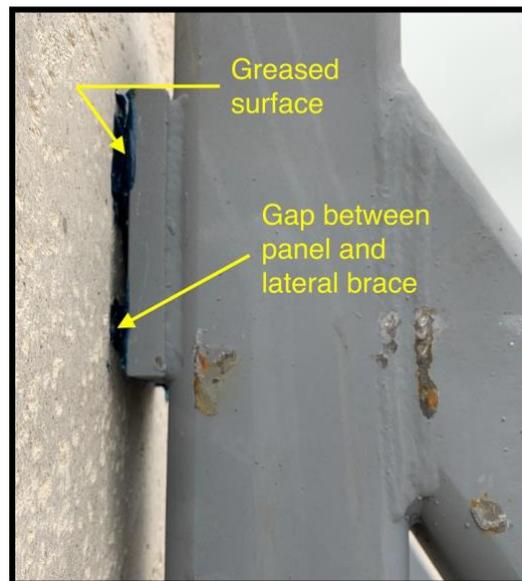
Figure 2. Overview of test panels and lateral bracing

(c) Gap and greased surface

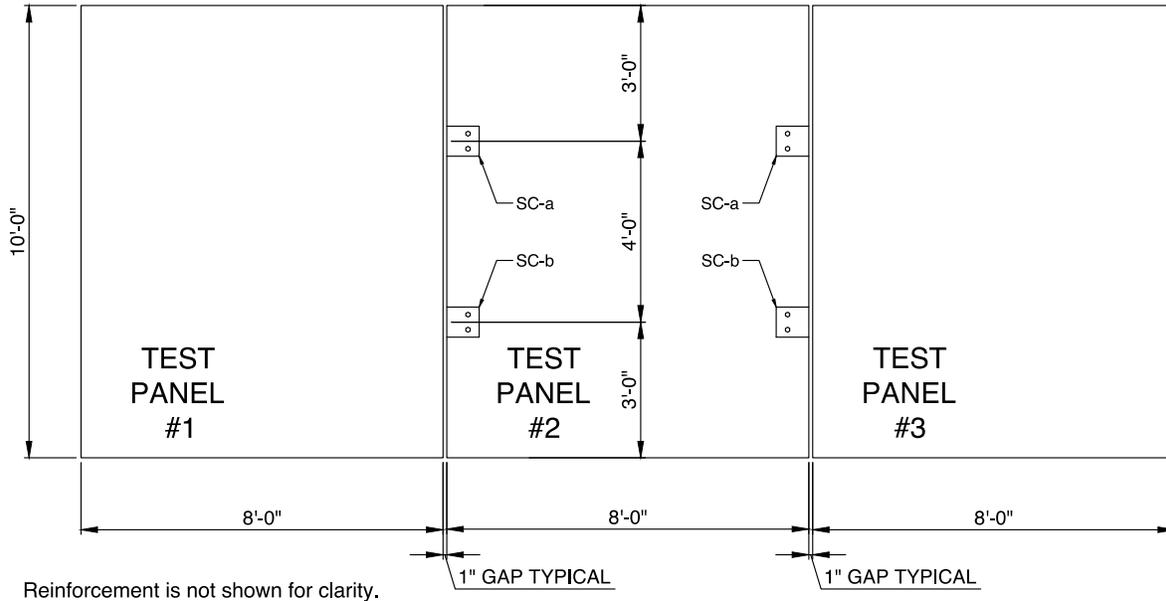
Figure 3. Locations of SC-a and SC-b

The focus of this series of tests was on SC-a and SC-b. The plate dimensions and bolt gages are different between these two devices as shown in Table 1, but both devices use 3/8" thick plates. In the first series, Panel 2 was connected to Panels 1 and 3 with SC-a, as shown in Figure 3. SC-b was used to connect the panels for the second series of tests. The devices for the two tests were 4'-0" apart so testing of one device will not impact the result of the other device. Each device had a 3'-0" edge distance.

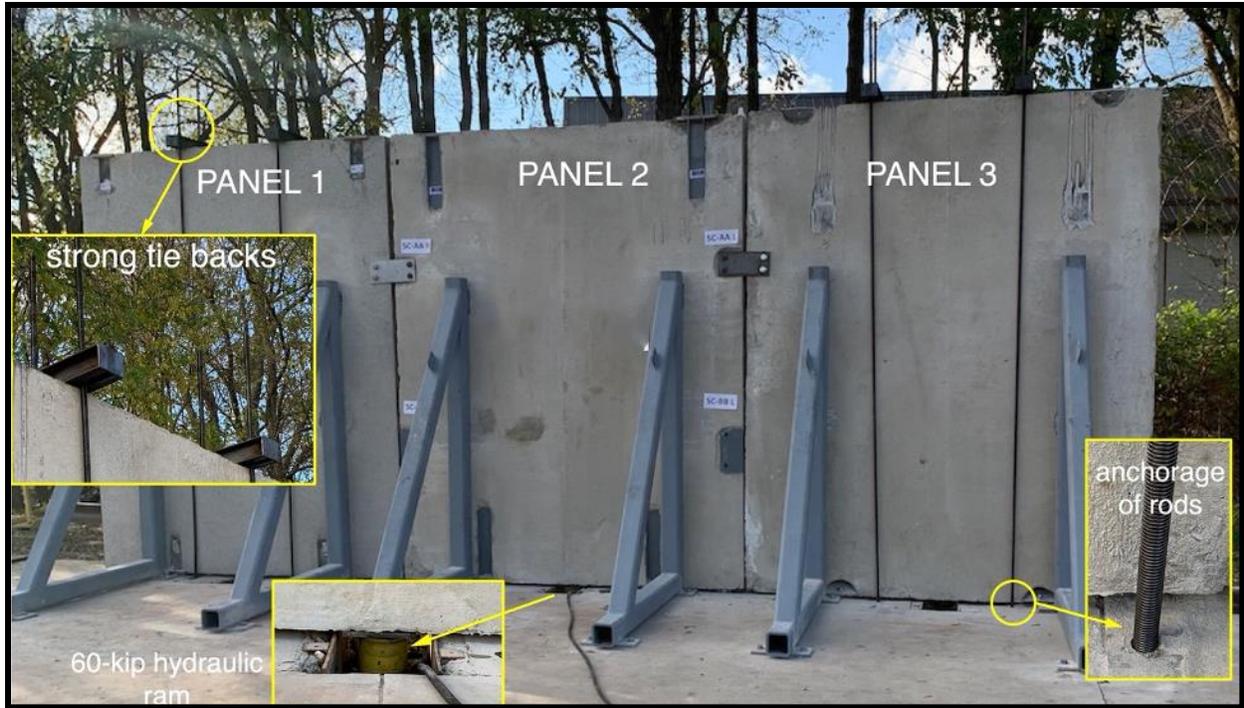
Figure 4. Test setup

The test setup is shown in Figure 4. Pockets had been cast in the foundation to accommodate hydraulic rams. A 60-kip hydraulic ram was placed vertically in a pocket in the middle of the Panel 2 to apply a vertical uplift force. The load was transferred to the panel through a bearing plate centered on the panel thickness. Each stationary panel (Panel 1 and Panel 3) was held in place by four 5/8" A193-B7 threaded rods that were threaded into anchors cast in the foundation and restrained at the top by two strong tie backs consisting of a pair of back-to-back channels.

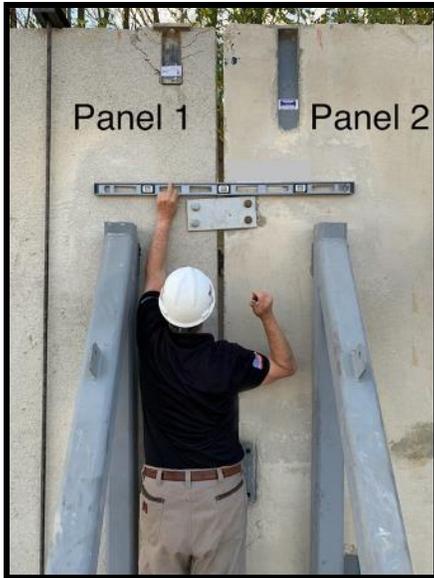
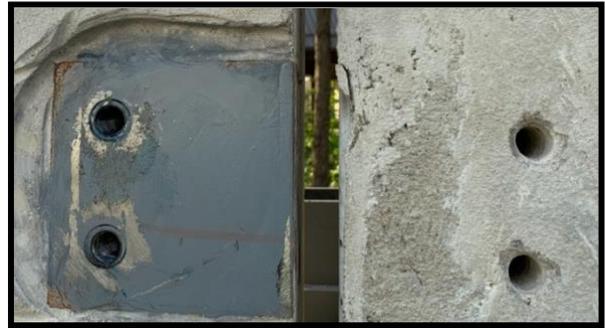
(a) SC-a

The maximum load resisted by each device is tabulated in Table 2. As evident from Figure 5, the connection plates in both devices rotated. This rotation is expected considering that the holes for the post-installed anchors (i.e., those in Panels 1 and 3) are slotted. Furthermore, the structural bolts (i.e., those in Panel 2) are not meant to be slip critical. No cracks were observed around SC-a, but diagonal cracks radiated from the top structural bolt which was subjected to tension as the plates rotated.

Both SC-a and SC-b resisted 10 kips suggesting the larger bolt gages in SC-b did not affect the capacity. The larger connection plates and bolt gages in SC-b did not impact the capacity.

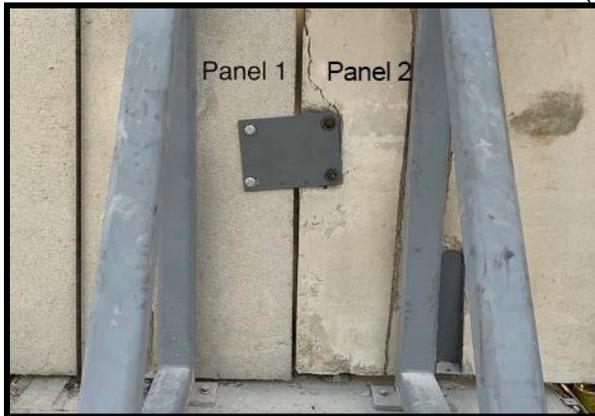
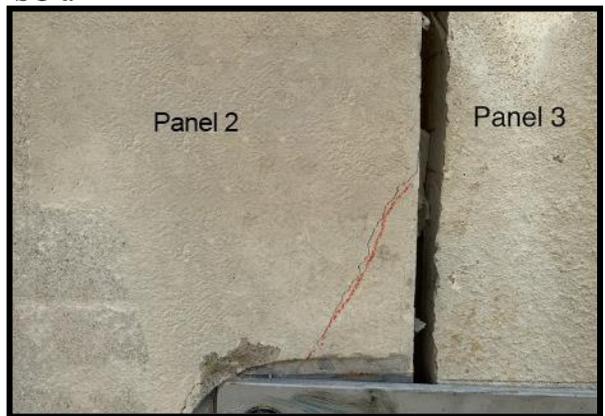
Figure 5. Condition of devices after resisting 10 kips

(b) SC-b
