# Full-Scale Testing of PA-EX Series

**Bahram M. Shahrooz, PE, FACI, FASCE, FSEI**  
**Director of University of Cincinnati Large Scale Test Facility**

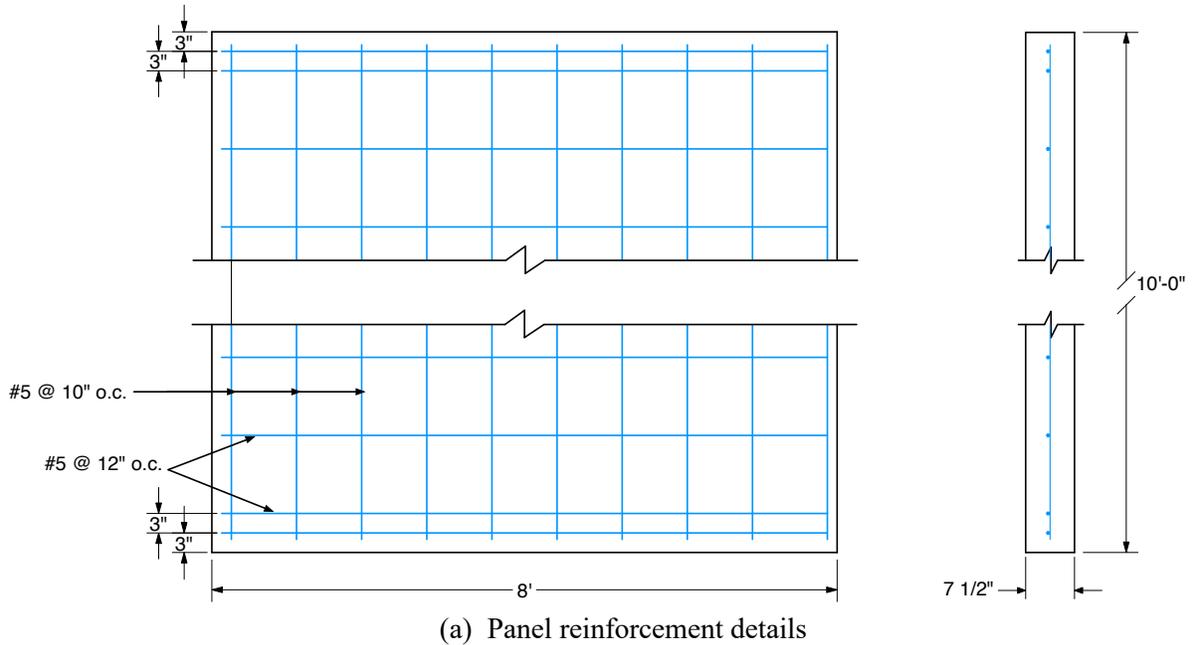
(a) Panel reinforcement details

Three 7.5" thick x 8'-0" wide x 10'-0" tall reinforced concrete panels were cast in order to test a number of AdvanConn devices under various loading configurations. The panels were reinforced with one curtain of No. 5 Gr. 60 reinforcing bars spaced vertically at 10" o.c. and at 12" o.c. horizontally. The reinforcement was placed at mid-thickness. The average 28-day concrete strength was 4,610 psi. Near the ends, where the devices were to be installed, the spacing between the horizontal bars was reduced to 3" based on common practice. The reinforcement layout is illustrated in Figure 1a. The photograph in Figure 1b shows the panel reinforcement and formwork. The panels were designed to allow multiple tests on each panel or three interconnected panels.

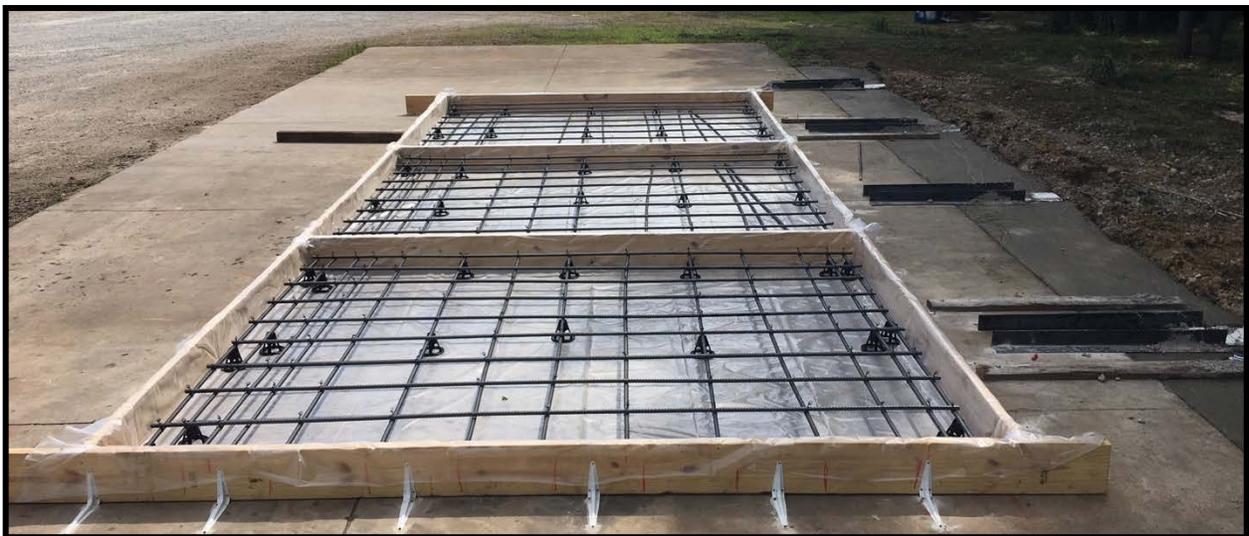
(b) Panels before concrete placement

Figure 1. Panel details

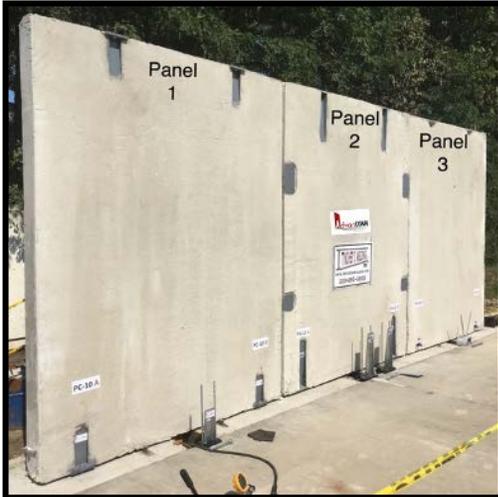
(a) Panels before bracing

After adequate curing, each panel was tilted upright (Figure 2a) and connected to a 24" wide by 30" deep foundation reinforced with No. 5 Gr. 60 reinforcing bars, and braced as shown in Figure 2b. Approximately 1/8" gap was kept between the panel and lateral braces. The panel at the contact point to the brace was ground and greased (Figure 2c). The combination of having a gap and the greased surfaces eliminated any potential influence of friction between the panel and lateral bracing system on the test results. It should be noted that the tests were conducted without any grout between the panel and foundation.

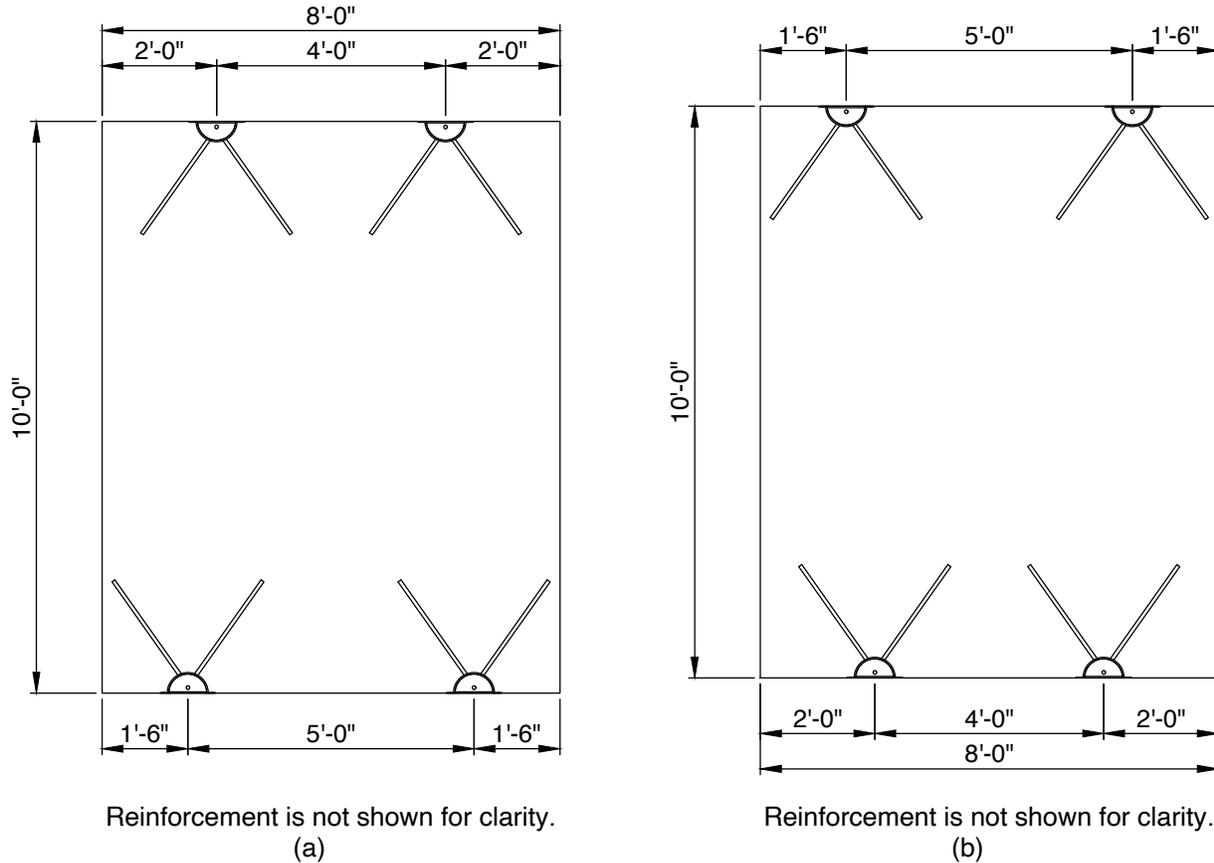
**Figure 3. Locations of PA-EX devices for test configuration a and b**

The focus of panel 3 was on PA-EX series. At one end of the panel two PA-EX series were placed at 1'-6" from each edge (Figure 3a) while two PA-EX series were placed with 2'-0" edge distance, which is the typical edge practice in practice, at the other end (Figure 3b). The panel was tested according to the loading protocol summarized in Table 1, in which "x" indicates a test was conducted.

Configuration and edge distance	Tension	In-plane shear	Out-of-plane shear	Combined in-plane and out-of-plane shear
a 1'-6" (Figure 3a)	x	---	---	---
b 2'-0" (Figure 3b)	---	x	x	x

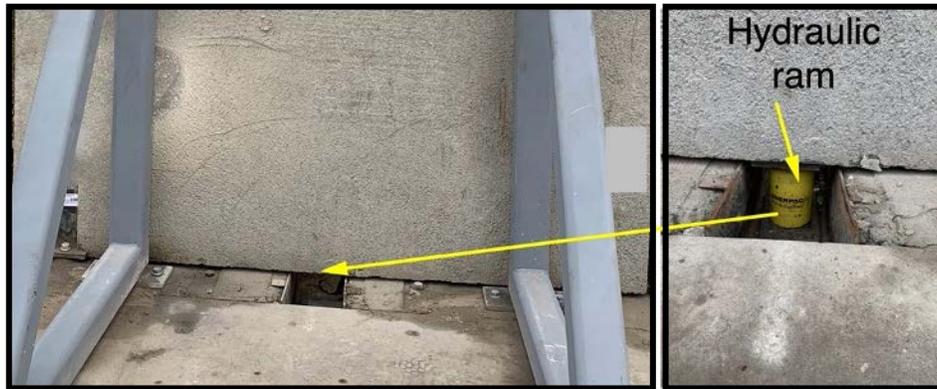
(a) Tension test

- (a) **Tension test:** A 60-kip hydraulic ram was placed vertically in a pocket in the middle of the panel to apply a vertical uplift force (Figure 4a). The load was transferred to the panel through a bearing plate centered on the panel thickness.
- (b) **In-plane shear test:** The loading device consisted of a longitudinal HSS in the plane of the panel and a transverse HSS that reacted against a pocket cast in the foundation – see Figure 4b. The load was applied by a 60-kip hydraulic ram. The load point, defined as the center of hydraulic ram, was 9.5" (vertically) from the bottom of panel, resulting in tensile/compressive force equal to  $9.5''/48''V = 0.198V$  ( $V$  is the applied in-plane shear force) in the devices for test configuration "b" in addition to the applied in-plane shear.

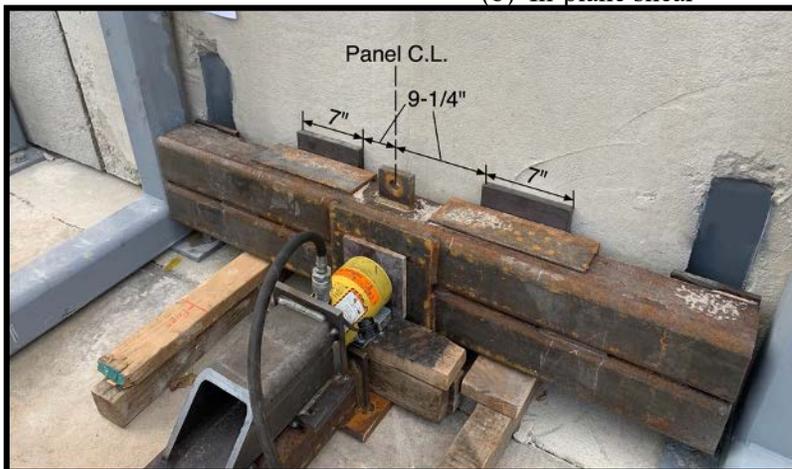
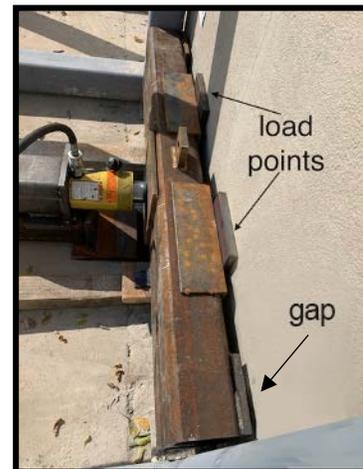
(c) Out-of-plane shear

- (c) **Out-of-plane shear test:** The panel was loaded in the out-of-plane direction through a reaction frame that was anchored to the slab on grade in front of the test panel (Figure 4c). The load, applied by a 60-kip ram, was transferred to the test panel through two 7"x7" plates placed at 9-1/4" from the panel centerline. The loading apparatus did not bear against the devices as evident from the gap shown in Figure 4c.
- (d) **Combined in-plane and out-of-plane test:** The panel was loaded in the out-of-plane direction first through the apparatus discussed in (c). After reaching the target shear, the out-of-plane load was maintained by closing a needle valve between the pump and hydraulic ram. The in-plane shear was subsequently applied.

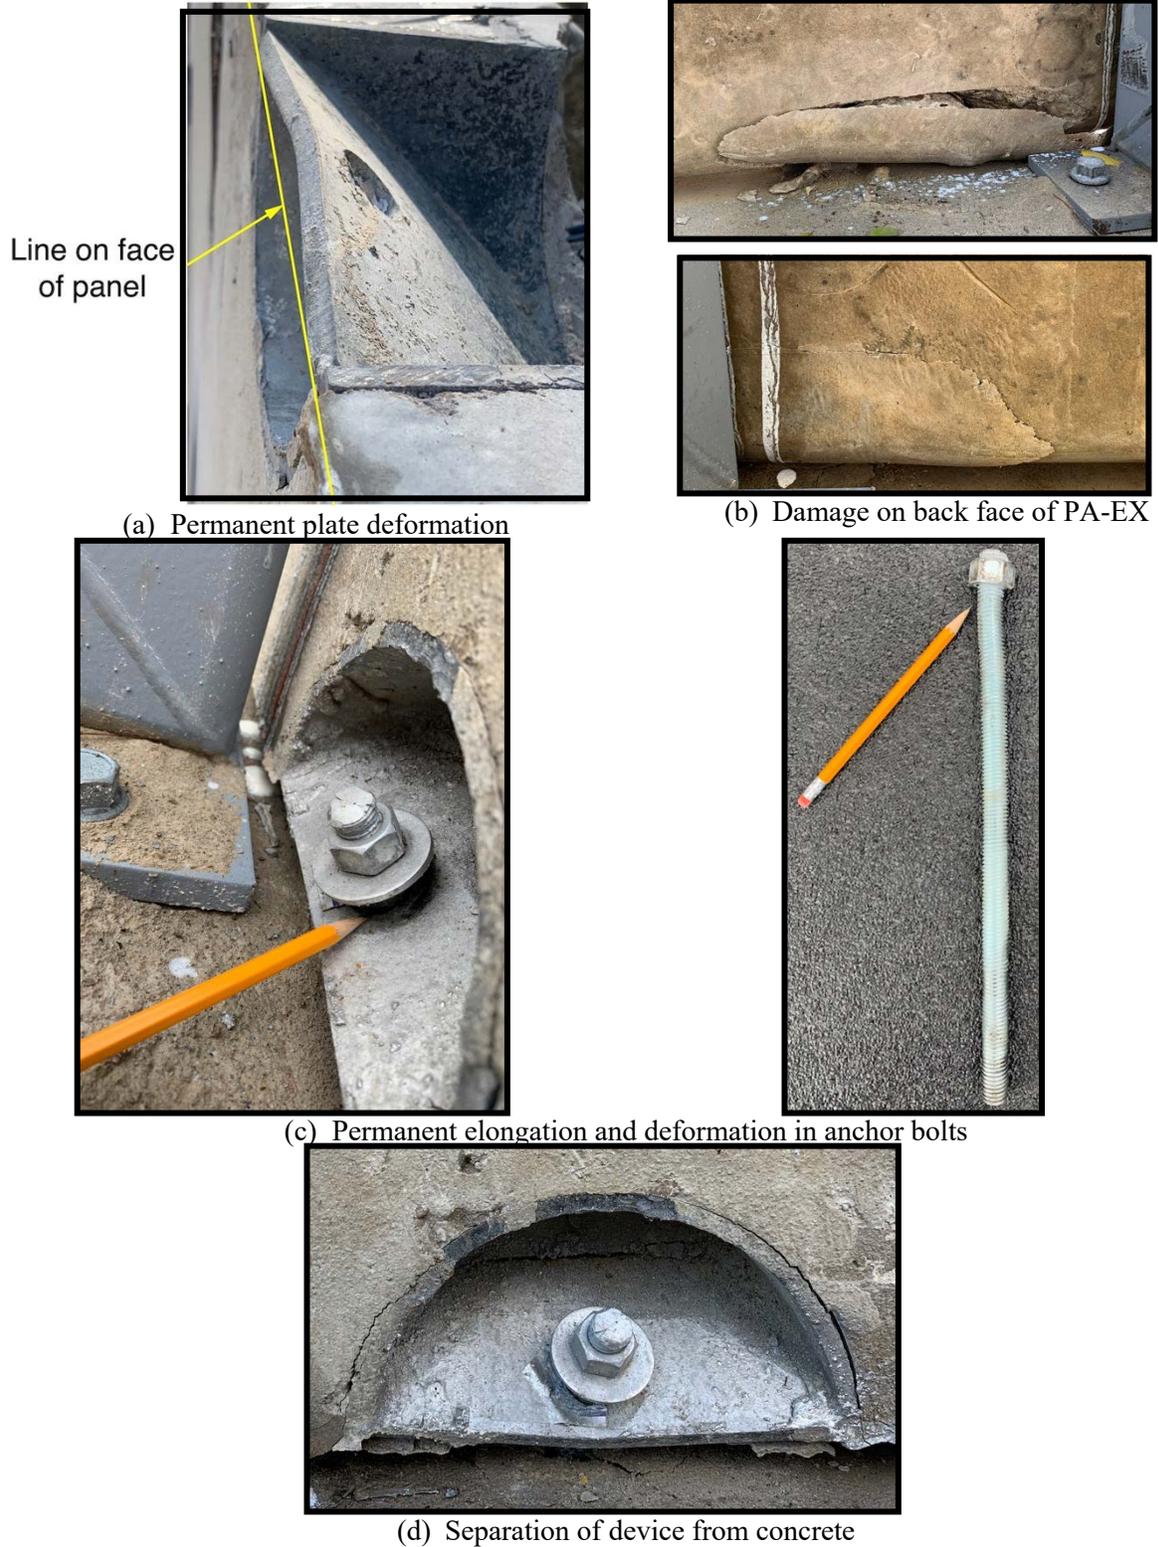
Tension loading for configuration “a” (1’-6” edge distance instead of the typical 2’-0”) was stopped after reaching 18.6 kips in each device. Additional load could not be applied beyond 18.6 kips due to bending of the device’s plate at the anchor point (Figure 5a), damage on the back face of the wall panel (Figure 5b) caused by bending of the plate, approximately  $\frac{3}{4}$ ” permanent elongation and bending of the anchor bolts (Figure 5c), and to a lesser degree because of slight cracking around the device (Figure 5d). It should be noted the floor slab on the back face of the device, which was not included in the tests, would restrain crack growth behind the device (Figure 5b) and the performance is expected to be better than that reported herein. The maximum applied load corresponds to 1.86 times the nominal design strength of 10 kips.

Figure 5. Cracking and damage after applying 18.6 kips tension in each device

Each PA-EX could resist 1.86 times the nominal design strength in tension even though the edge distance was 1'-6" instead of 2'-0" commonly used in practice. The devices could not resist additional loads beyond 1.86 times the nominal design strength in each PA-EX primarily due to a combination of (a) excessive bending of plate through which the device is anchored, (b) damage to the concrete behind the device, and (c) major elongation and bending of the anchor bolts. The presence of floor slab on the back face of the device, which was not simulated in the tests, would restrain growth of cracks behind the device and should enhance the performance. The reported load carried by each device accounted for the self-weight of the panel. Additional superimposed dead load and live loads were, however, not simulated in the tests. Clearly, such gravity loads would enhance the performance of PA-EX device.

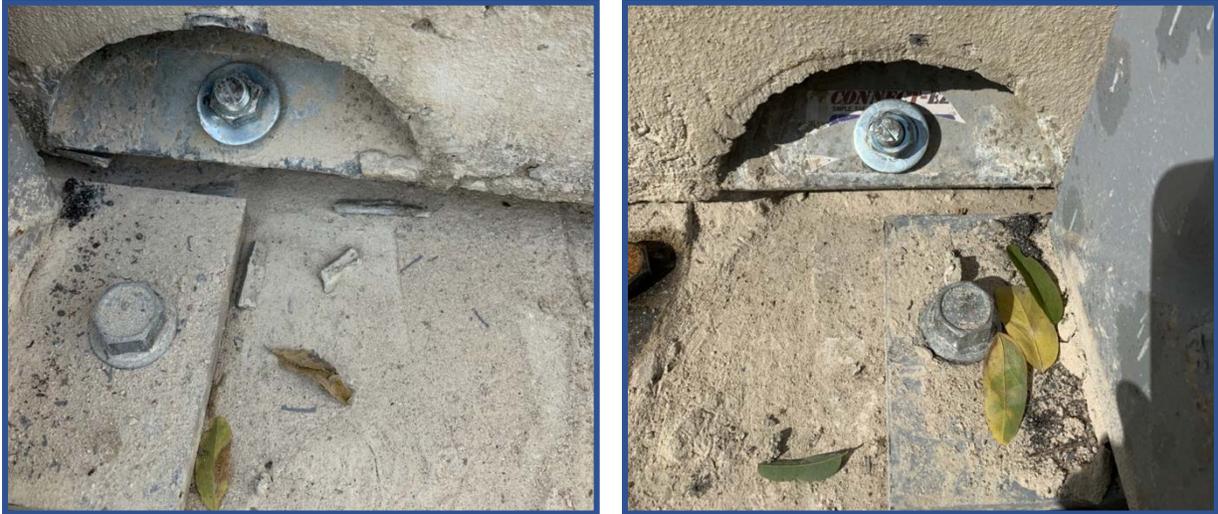
Each device in configuration “b” (2’-0” edge distance to the device) was subjected to (1) 10.1 kips in-plane shear (2) 10.1 kips out-of-plane shear, and (3) 14.3 kips combined in-plane and out-of-plane shear. Each device was loaded to slightly above the shear resistance of each anchor bolt alone (“resistance of steel”,  $\phi_{sa}V_{sa}$ ), which is 9.89 kips. The concrete around the devices did not crack during any of the shear tests. However, as seen from Figure 6, the device closer to the application of in-plane shear cracked after being subjected to 14.3 kips of combined in-plane and out-of-plane shear, but no cracking was found around the far end device. This behavior is expected as the device closer to the application of in-plane shear was subjected to a tensile force equal to  $0.198V = 0.198*10.1$  kips = 2 kips (where 10.1 kips is the applied in-plane shear) in addition to the combined shear of 14.3 kips. The forces in the far end device consisted of a combined shear of 14.3 kips and a compressive force equal to 2 kips.

(a) PA-EX away from the application of in-plane shear

(b) PA-EX close to the application of in-plane shear

**Figure 6. Status of the devices applying 14.3 kips combined in-plane and out-of-plane shear in each device**

Each device could resist at least the shear capacity of the anchor bolt alone, so called "shear resistance of steel", for all the three types of shear tests (in-plane, out-of-plane, and combined in-plane and out-of-plane). The concrete around both PA-EX devices remained uncracked.
